Laboratory of Medical Biopathology and Molecular Medicine Eygenideio Clinic University of Athens Papdiamantopoulou 20 Ilisia Athens

Test investigation under real conditions on the effectiveness of a photocatalytic paint system in reducing the bacterial load in certain environments –the interior walls and the room indoor air

Test investigation, under real conditions, on the effectiveness of the photocatalytic paint system in reducing the bacterial load in certain environments: the interior walls and the indoor air, at Eygenideio Clinic of Athens University (www.eugenideio.uoa.gr)

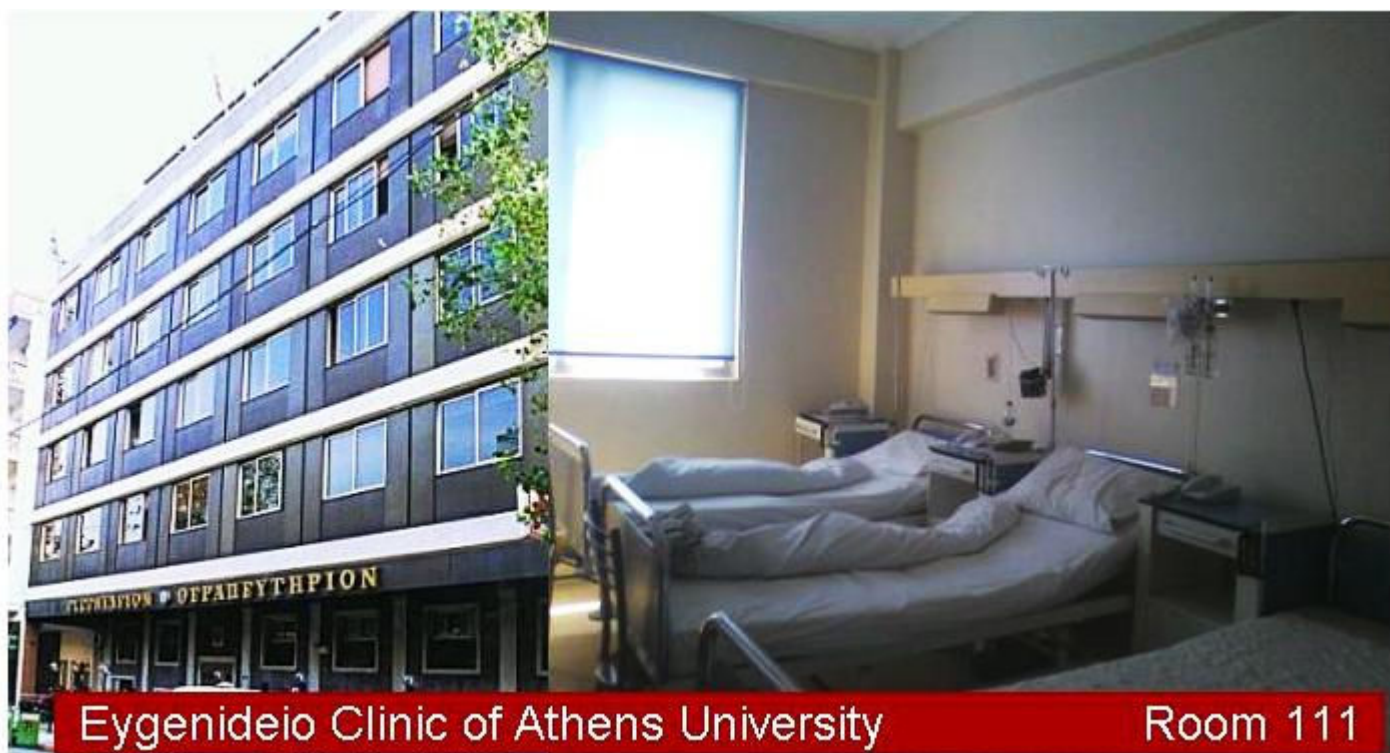
8/5/2008

Test Examination Room 111 Before treatment with Photocatalytic Coating			
Investigation Area	Mackonkey Agar	Sabouraud Agar	Blood Agar
Walls	Barren	Barren	5 Colonies/ m ² Staphylococci
Indoor Air	3 Colonies/ m ³ Gram (-) Bacteria	5 Colonies/ m ³ Penicillium	600 Colonies/ m ³ Staphylococci- micrococcus

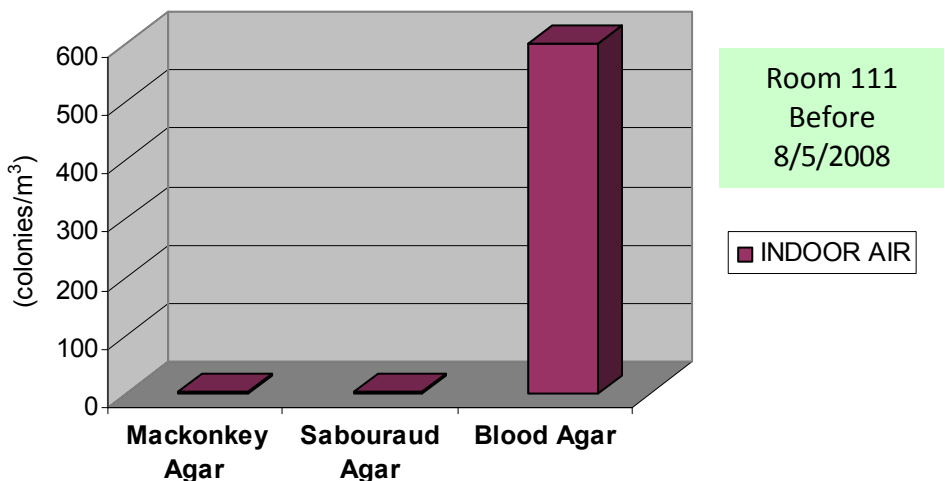
Figure 2: Test results for Mackonkey Agar, Sabouraud Agar and Blood Agar in the indoor air of the room before the application of the photocatalytic coating

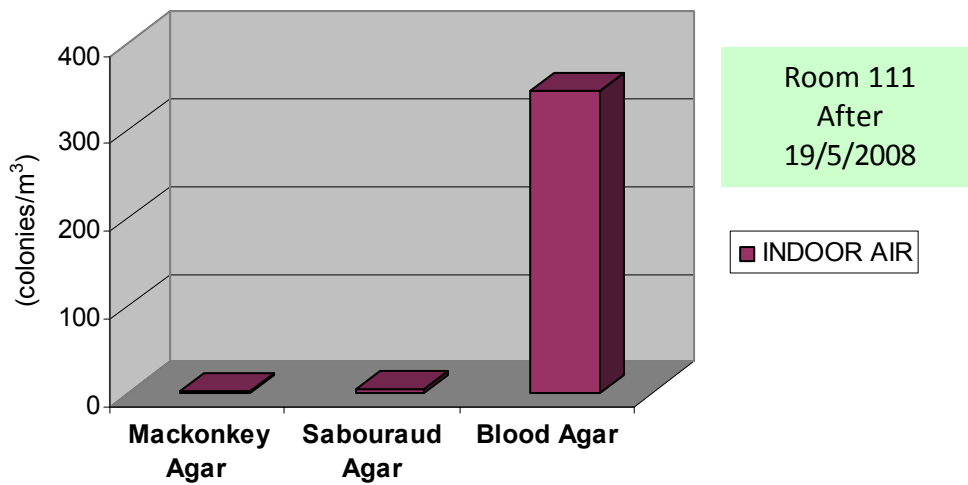
Figure 4: Test results for Mackonkey Agar, Sabouraud Agar and Blood Agar in the indoor air of the room after the application of the photocatalytic coating

Test Examination Room 111 After treatment with Photocatalytic Coating			
Investigation Area	Mackonkey Agar	Sabouraud Agar	Blood Agar
Walls	Barren	Barren	Barren
Indoor Air	2 Colonies/ m ³ Gram (-) Bacteria	6 Colonies/ m ³ Penicillium	345 Colonies/ m ³ Staphylococci- micrococcus
Dry coating Sample	Barren	Barren	Barren
